# Structural Assessment of Mahakam Bridge Geometry Using Geodetic GPS and Terrestrial Laser Scanner

| Article Info | Abstract |
|---|---|
| <b>Article history:</b><br><br>Received 5 January, 2025<br>Revised 1 February, 2025<br>Accepted 25 February, 2025 | This study employs a terrestrial laser scanner and geodetic GPS to assess the camber elevation, lateral drift, and pilecap inclination of the Mahakam I Bridge in Samarinda, East Kalimantan. The camber inspection results reveal variations in the elevation of spans B3, B4, and B5, with the lowest measured at 68.74 m and the highest at 70.35 m. The lateral drift analysis on piers P2, P3, and P4 indicates minimal displacements, with maximum deviations ranging from -0.05% to 0.29%. The inclination angles of the pilecaps on P2, P3, and P4, measured at 90.411°, 90.128°, and 90.112°, respectively, exhibit slight deviations from the optimal 90° alignment. These findings highlight the need for continuous monitoring and potential structural adjustments. The study underscores the critical role of precise geometric assessment in preserving bridge integrity and ensuring long-term structural stability. Further investigations and mitigation stra

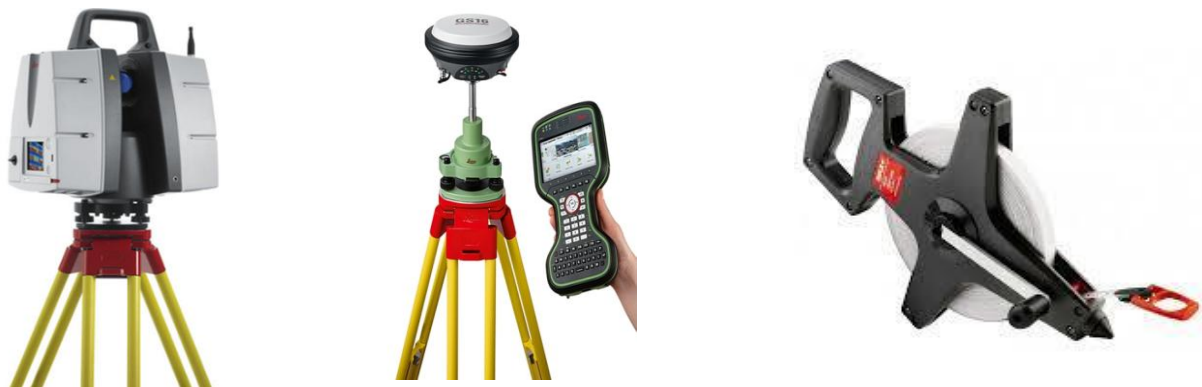
**Figure 2.** (a) Leica Scanstation HDS P30 (b) Leica GPS GS 16 (c) Measuring Tapes

The Terrestrial Laser Scanner (TLS), specifically the Leica Scanstation P30, is a highly accurate surveying instrument that uses laser technology to capture the shape and dimensions of objects rapidly and with great precision. With a range accuracy of  $1.2 \text{ mm} + 10 \text{ ppm}$  and a scanning rate of up to 1,000,000 points per second, the TLS ensures the collection of highly detailed 3D spatial data, which is critical for the analysis of the bridge's geometry. It is equipped with a dual-axis compensator, which ensures the stability of measurements across various angles.

The Geodetic GPS (Leica Viva GS16) plays a complementary role in the geometric inspection by providing high-precision real-time and post-processed positioning. It leverages satellite signals to obtain accurate coordinates and elevation data. The GPS system is capable of RTK (Real-Time Kinematic) initialization within approximately 4 seconds and supports various communication protocols such as USB, Bluetooth, GSM/GPRS, and UHF/VHF modem connectivity, enhancing the flexibility of data acquisition in the field [3] [4] [5] [6] [8].

In addition to the TLS and Geodetic GPS, measuring tapes (ranging from 3 to 5 meters for small-scale damage assessment and 50 to 100 meters for larger-scale measurements) are utilized to assess the extent of damage to the bridge deck and surrounding areas. The digital camera is employed to capture visual documentation of the structural condition, which serves as a reference for further analysis and repair planning. Together, these tools provide a comprehensive set of instruments for inspecting and documenting the structural state of the Mahakam I Bridge.

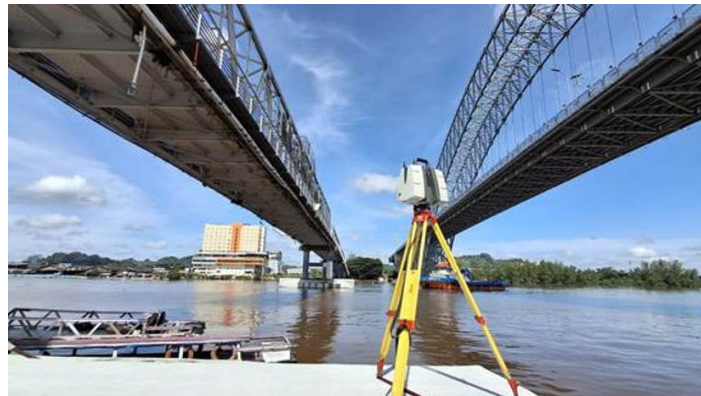
The geometric inspection of the Mahakam I Bridge is conducted using the Terrestrial Laser Scanner (TLS) and Geodetic GPS, which work in conjunction to provide high-precision measurements of the bridge's structural geometry. The TLS is based on the Surface Scan method, which utilizes laser or photogrammetric technology to collect data on the shape and surface condition of objects. The Surface Scan method involves three main steps: emitting laser signals onto the surface of the structure, measuring the time taken for the reflected laser signals to return, and generating a highly accurate 3D model from the collected data. This method enables the precise measurement of critical components, such as the camber area, pile cap, and vertical alignment of the bridge's pillars. The inspection also includes defining scanning areas and boundaries to ensure comprehensive coverage of the bridge's structural elements [21] [22].

**Figure 3.** Inspection Methode

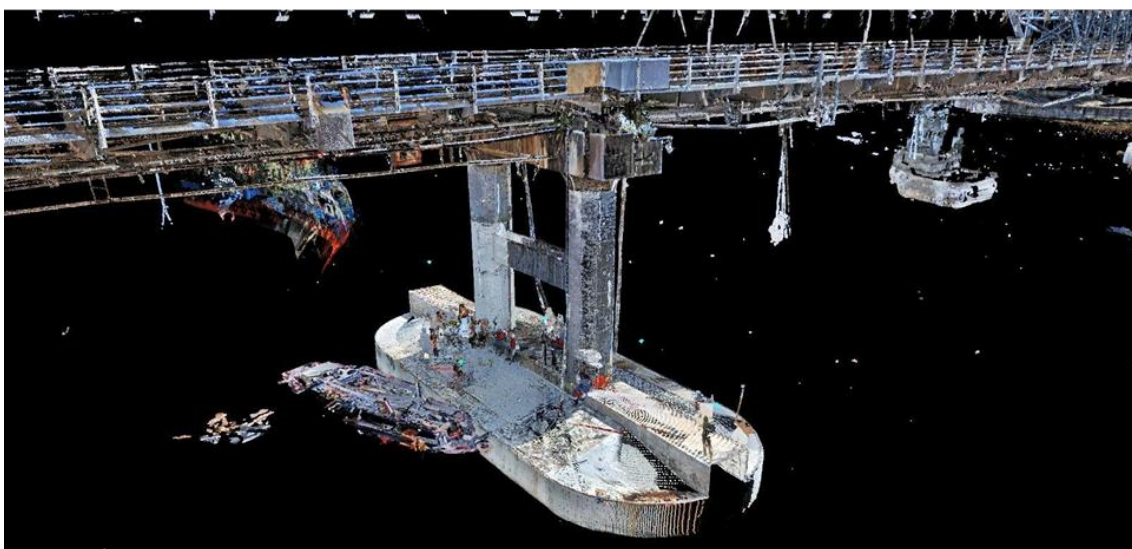
**Figure 6.** 3D scanning results before filtering
